Range Road Dump Stabilization Project

CRE-53-06

EDI Project No.: 06-YC-0023

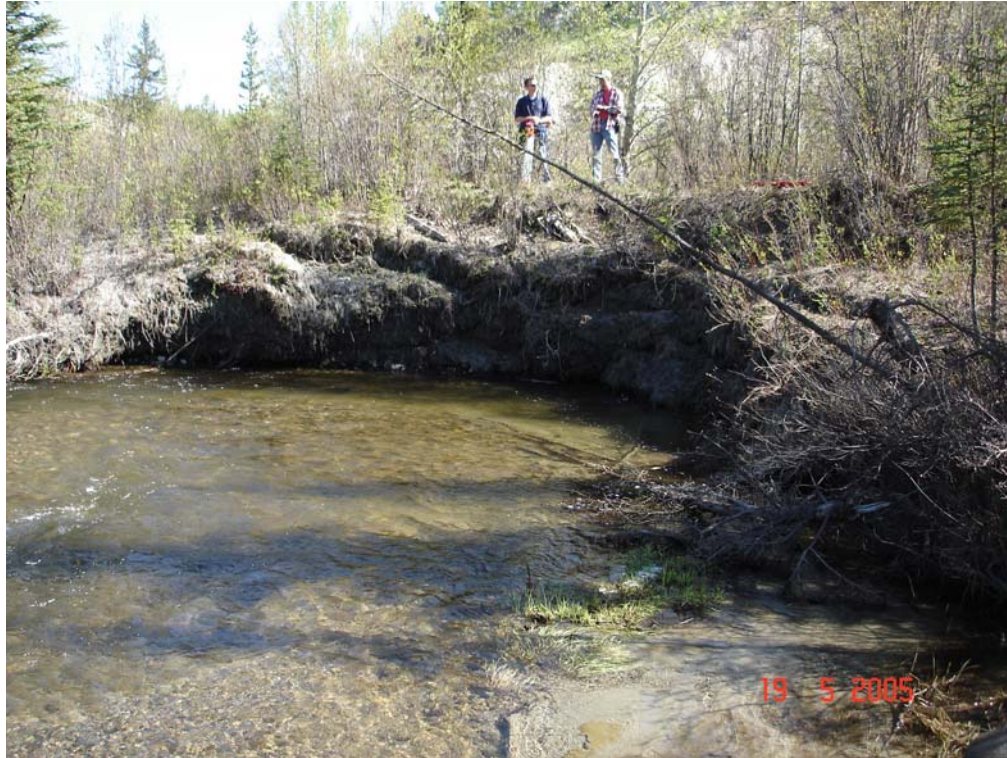
Photo 1. Downstream view of McIntyre Creek at the upstream end of existing berm. Significant undercutting of the bank adjacent to the berm has occurred at this site.

Currently the creek is eroding the upstream end of the berm (photos 1 and 2). If this was to continue, McIntyre Creek would eventually breach the berm and flow into its original channel. This would result in the mobilization of both refuse and contaminants from the dumpsite into the Yukon River. As such, the Ta'an Kwäch'än Council (TKC) proposed to construct a secondary berm away from the stream channel that would prevent McIntyre Creek from entering the toe of the dump, should the old berm breach (Figure 2). The objectives of this project as listed in the project proposal included:

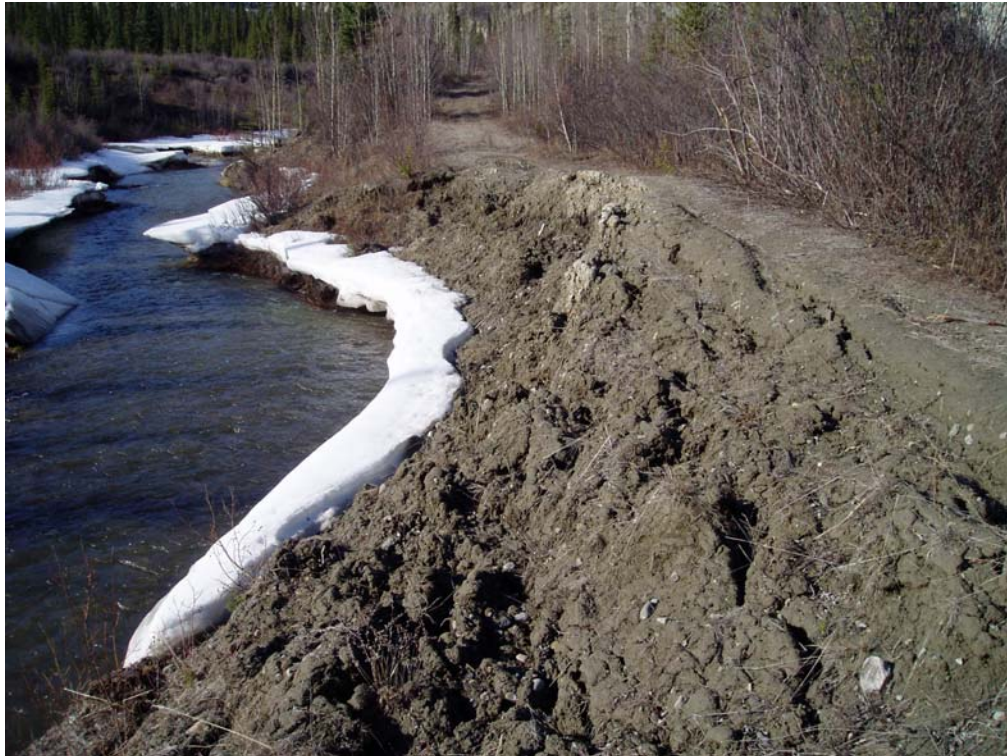
Photo 2. Downstream view of McIntyre Creek near the upstream end of berm. Significant erosion of the berm has occurred at this site.

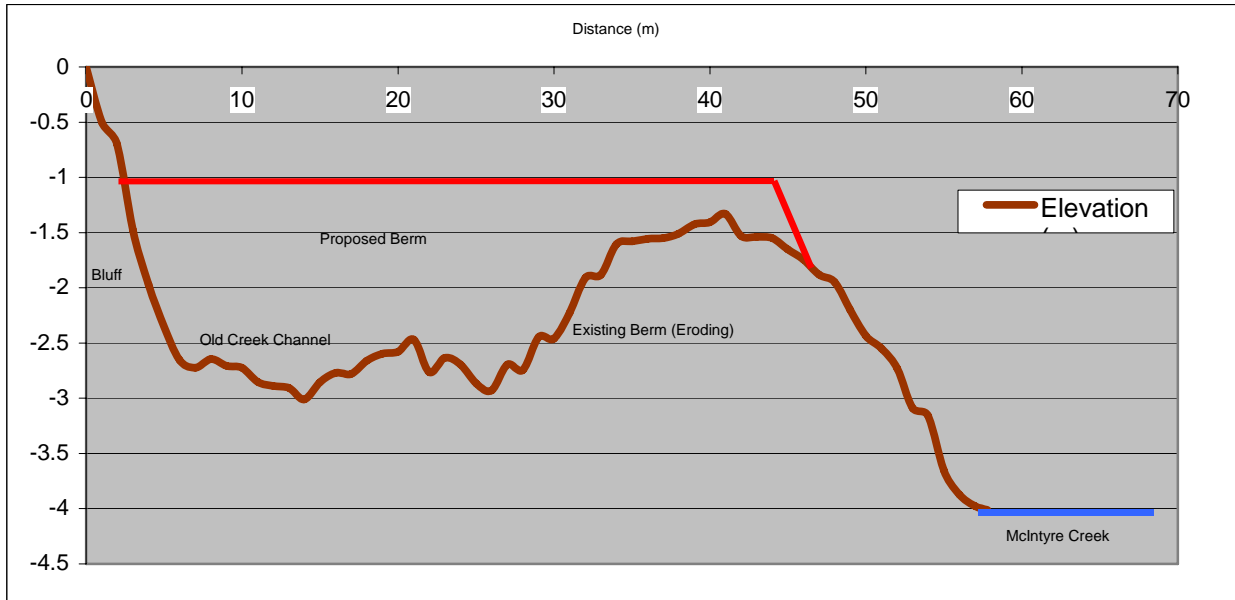
Figure 3: Longitudinal profile of proposed berm site.

The proposed new berm was designed to tie into the existing berm at the downstream end. It was to extend approximately 42 m to connect into an existing hill slope (see Figure 2). It was proposed to be constructed of approximately 360 m³ of granular fill material. This was based on a berm height of approximately 0.5 m above the height of the existing berm (at the surveyed location), the top of the berm being 2 m wide and the slopes of the berm being 2:1¹. This material was to be hauled in, as no such material is available on site. The material was to be trucked to the top of the dumpsite and moved down the slope via bulldozer to the new berm location.

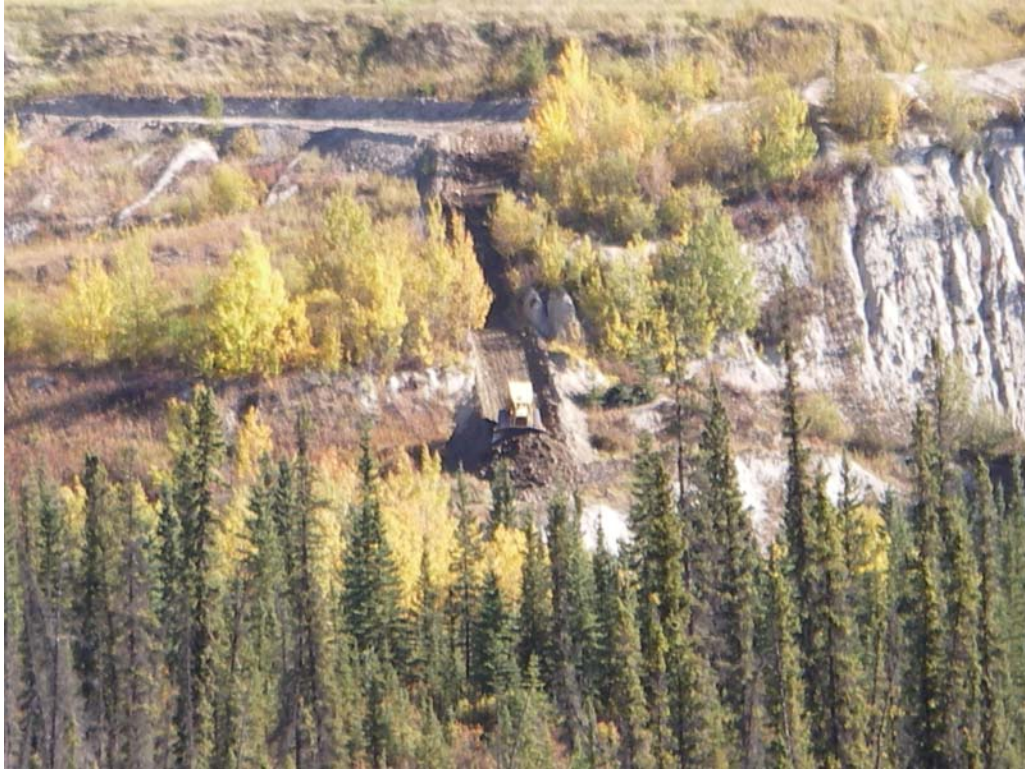
Photo 3. View of bulldozer pushing fill material down the slope. Note that berm location is in the valley behind the trees (in the foreground).

The initial project plan called for 360 m³ of fill material to be pushed down the slope from the top of the dumpsite. While this amount of material accounted for some loss (approximately 220 m³ was needed for the berm), further inspection by the construction crew (including City of Whitehorse personnel) revealed that significantly more material was required. The issue was that it was a significantly long (approx 200 m) push down a very steep slope, with some extreme pitches. Essentially, to ensure that the cap material on the dumpsite was not significantly disturbed, additional fill material was needed to construct a road down to the berm location (photos 3 and 4).

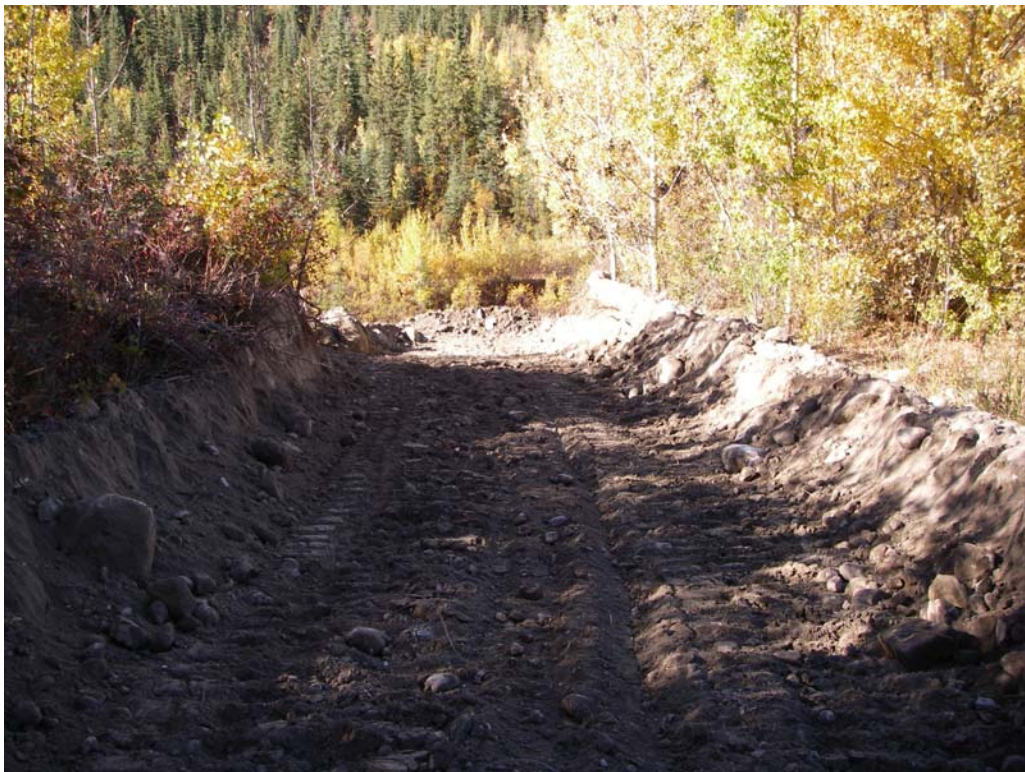
Photo 4. Downslope view of path used by bulldozer to push material down slope.

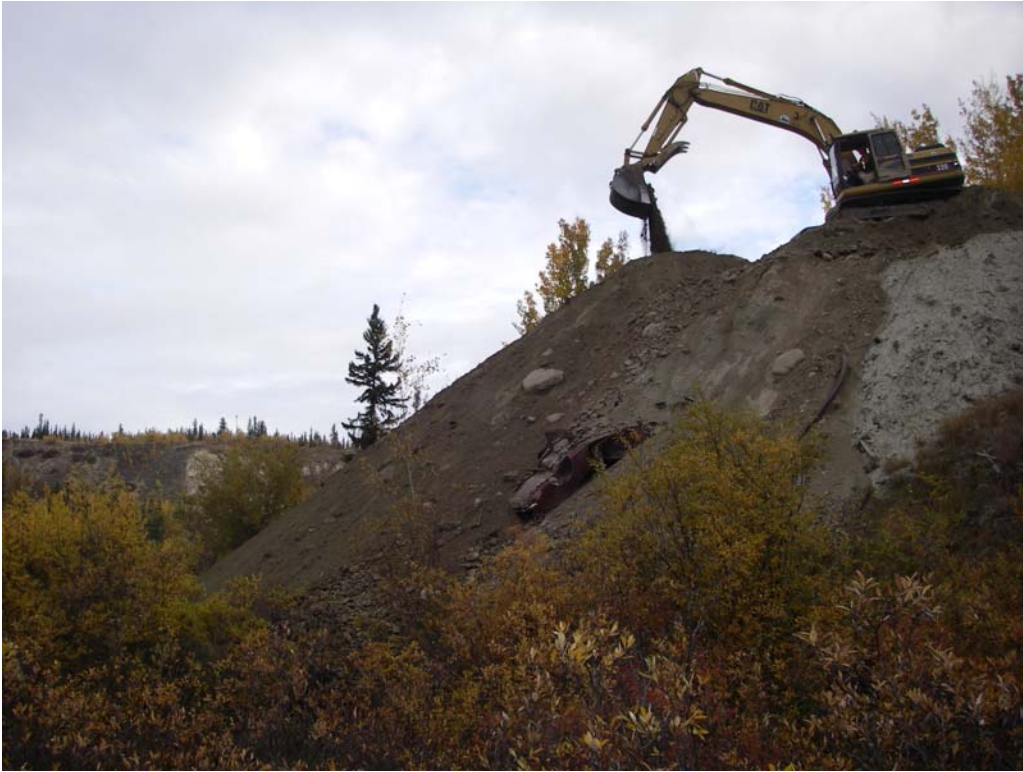
Photo 5. Excavator bailing material over slope. Proposed berm location to the bottom left of the photo.

Once all of the fill was delivered and the bulldozer pushed as much material downslope, the excavator bailed much of the fill material over the bottom slope in the location of the proposed berm (Photo 5).

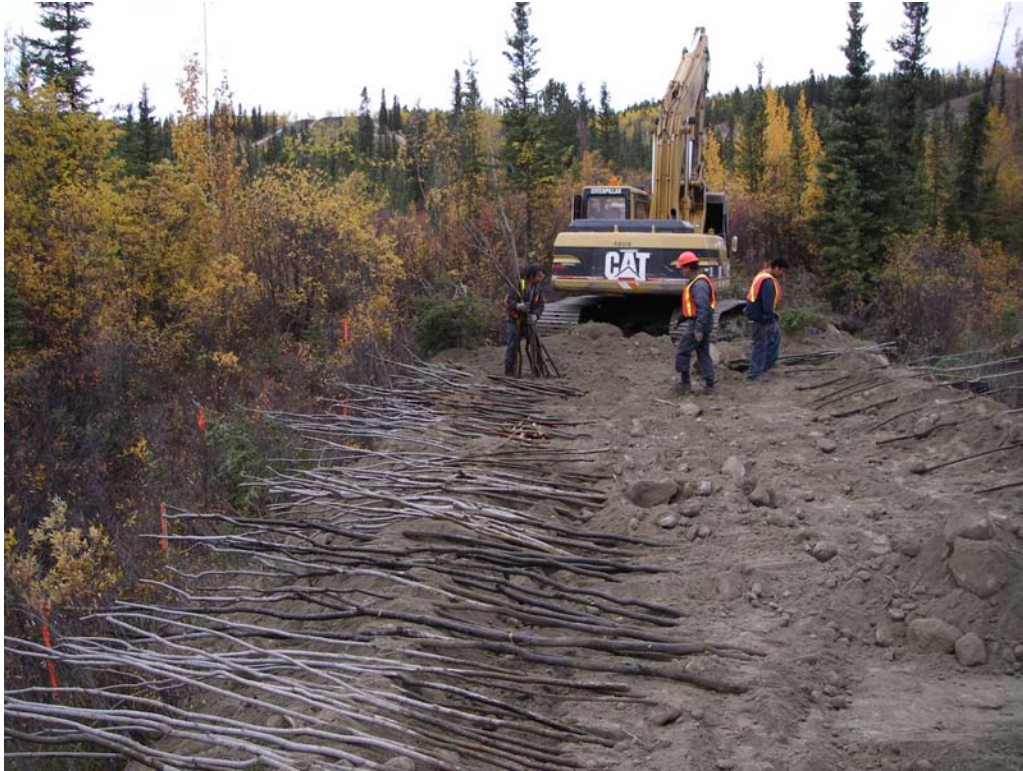
Photo 6. Willow and poplar stakes incorporated into the berm (brush layers).

As the ground in the area of the berm was soft, the excavator had to use the berm as a work platform. As such, material was placed in a layered fashion, with the excavator running back and forth on the top of the berm to compact the material. Three lifts or rows of brush layering were incorporated in the berm (Photos 6). Species used included willow (*Salix* spp.) and balsam poplar (*Populus balsamifera*), both of which are prevalent on the site at present.

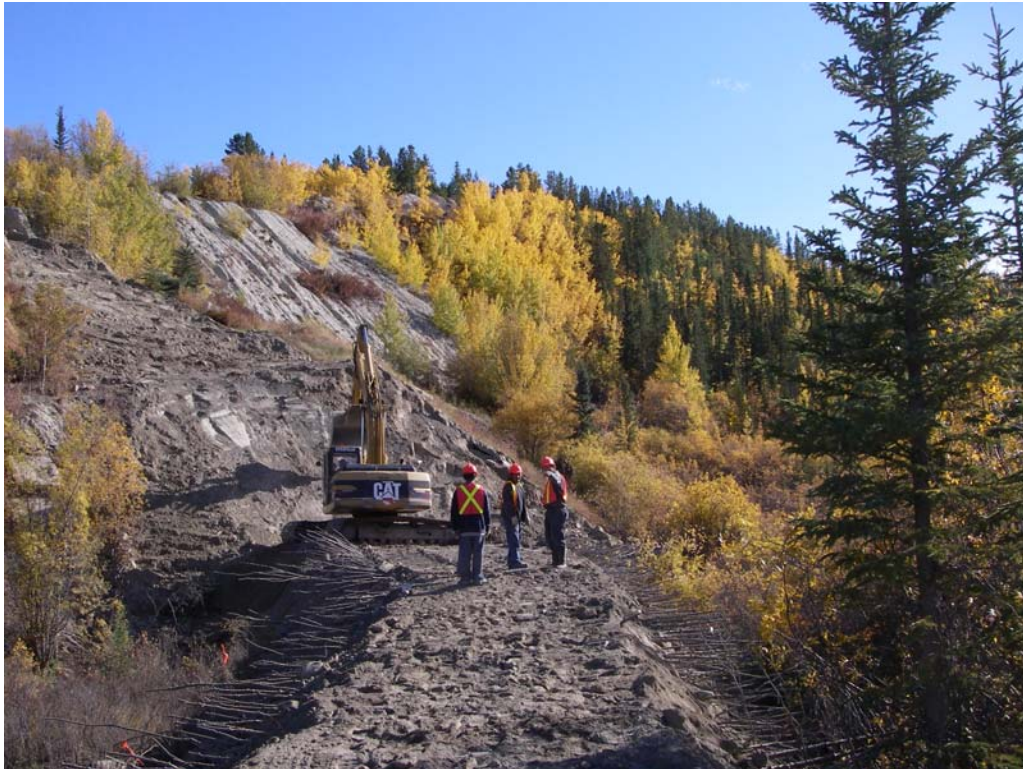
Photo 7. Berm nearing completion, taken from old berm location near McIntyre Creek.

As the excavator had to use the berm as a work platform, the top of the berm ended up to be wider (> 2.2 m) than originally planned (2 m; Photo 7). As the wider berm required additional fill material, which was a limiting, it was decided that the slopes of berm would be reduced to 1.5:1, rather than the original design of 2:1. Given that the resulting berm is wider at the top and presumably stronger than the original design, this was not seen to be an issue that affected the objective of the berm.

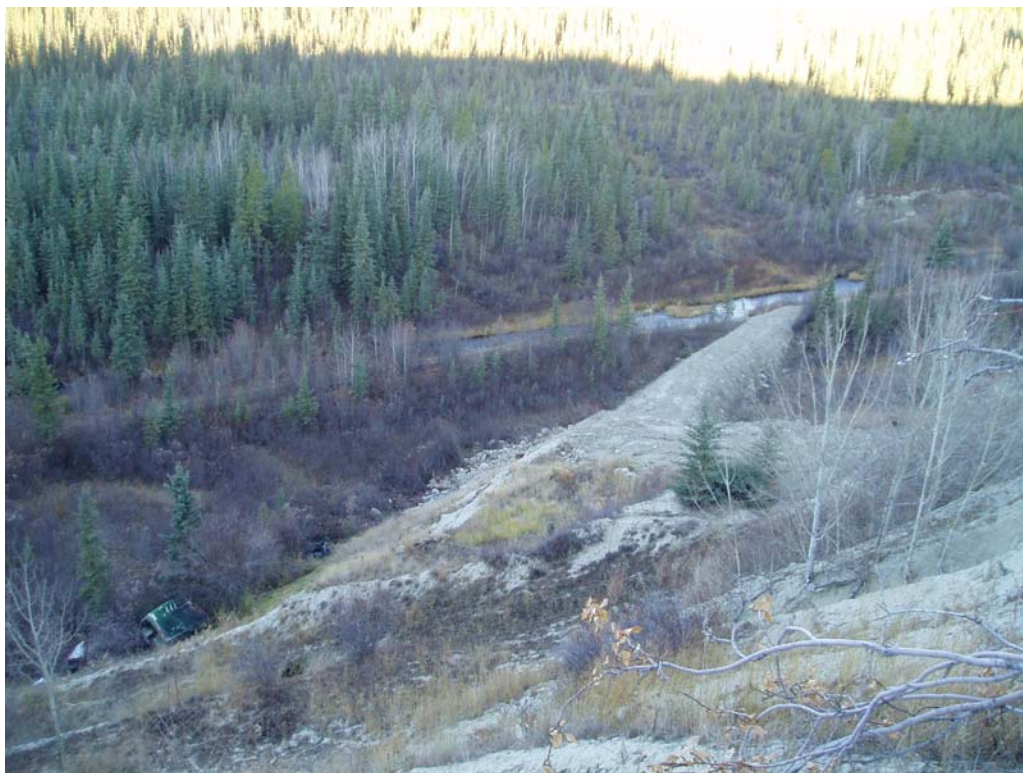
Photo 8. Completed berm with McIntyre Creek in background (flowing left to right).

The completed berm on average was over 0.75 m higher than the lowest portion of the existing berm (within 10 m of their intersection). Photos 8 and 9 demonstrate the angle of the berm in relation to McIntyre Creek which is conducive to directing the stream back into its channel following an upstream breach of the berm. In order to provide moisture for the brush layers, the berm was watered using a 2-inch pump. The berm was grass seeded with native seed. It should be noted that a significant rainfall event occurred in the area a few days following construction completion.

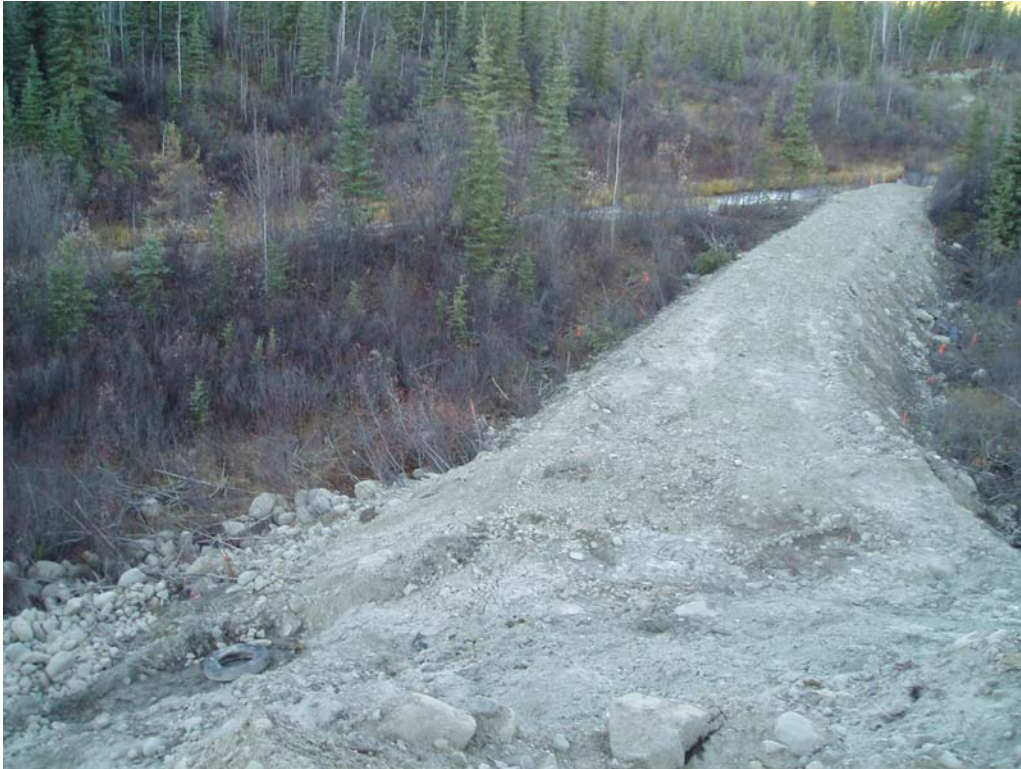
Photo 9. Completed berm with McIntyre Creek in the background.
