Klusha Creek & Tatchun Creek Ongoing Obstruction Management 2004

FINAL REPORT

Yukon River Panel Project CRE-04-35

August 2004

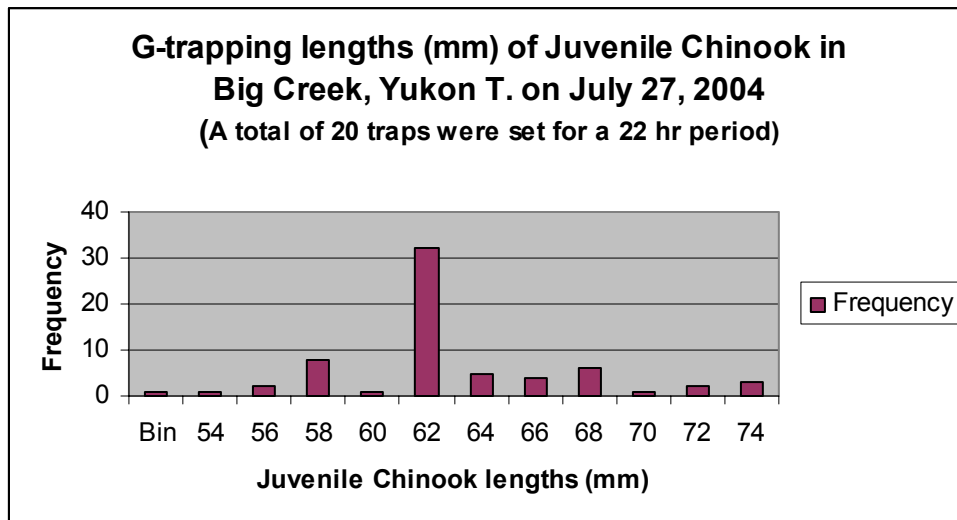
Figure 1: G-trapping results from Big Creek, Yukon T. showing the lengths of juvenile Chinook captured and their frequency.

G-trapping was conducted on Big Creek, Yukon Territory trapping for juvenile Chinook salmon. Larger juvenile Chinook captured were approximately 75mm in length and the smaller juveniles were 65mm (Figure 1). A total of 20 traps were set for a 22 hour period on July 26, 2004 and retrieved on July 27, 2004. Data sheets were submitted to Fisheries and Oceans Habitat Enhancement Branch.

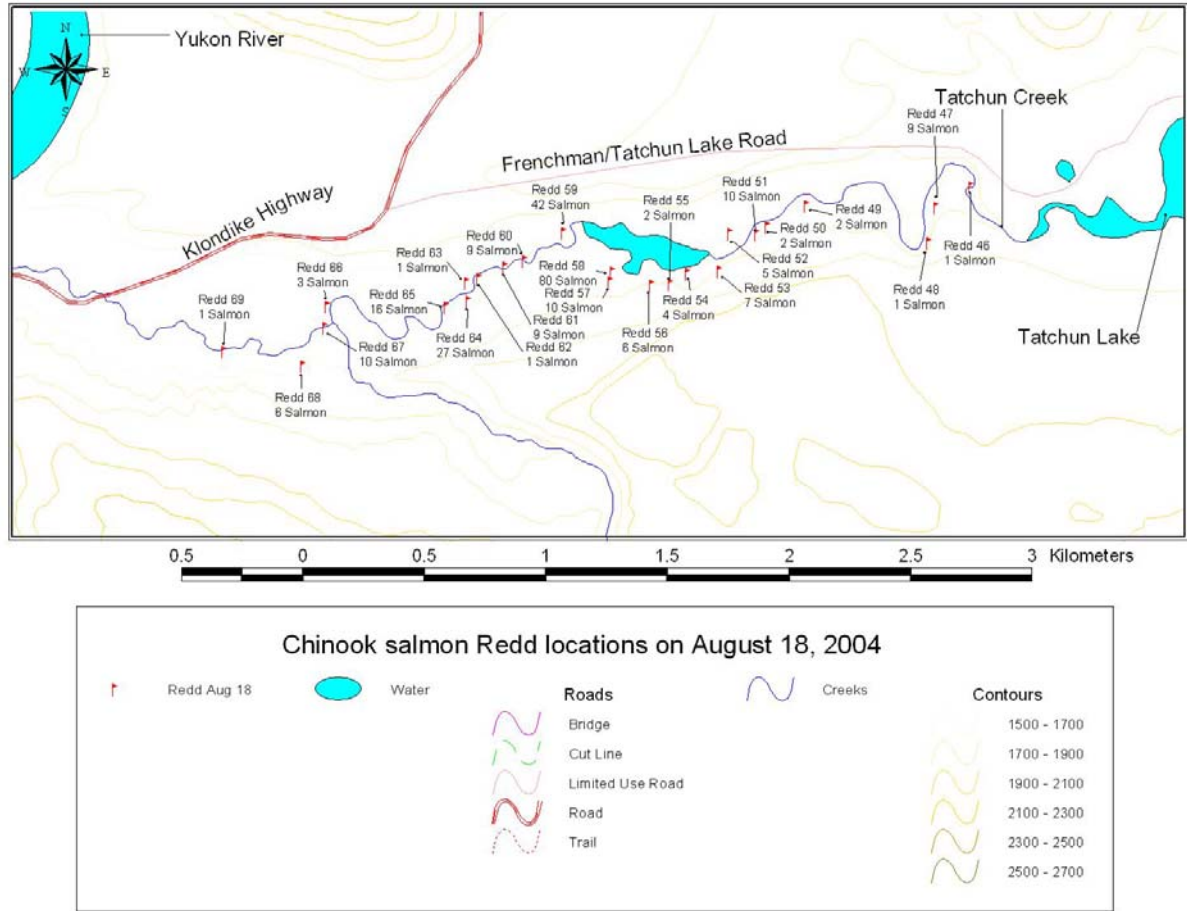
Figure 5: Chinook salmon Redd locations and numbers observed on Tatchun Creek from Tatchun Lake to the campground on August 18, 2004. Beaver Dam Pond is located at the center of the map downstream from Tatchun Lake.

On August 18, 2004 a full count was conducted from downstream of Tatchun Lake to the campground, a total of 264 Chinook salmon were observed. Redds ranged from 80 to 1 Chinook with a mean of 11 (Figure 5).

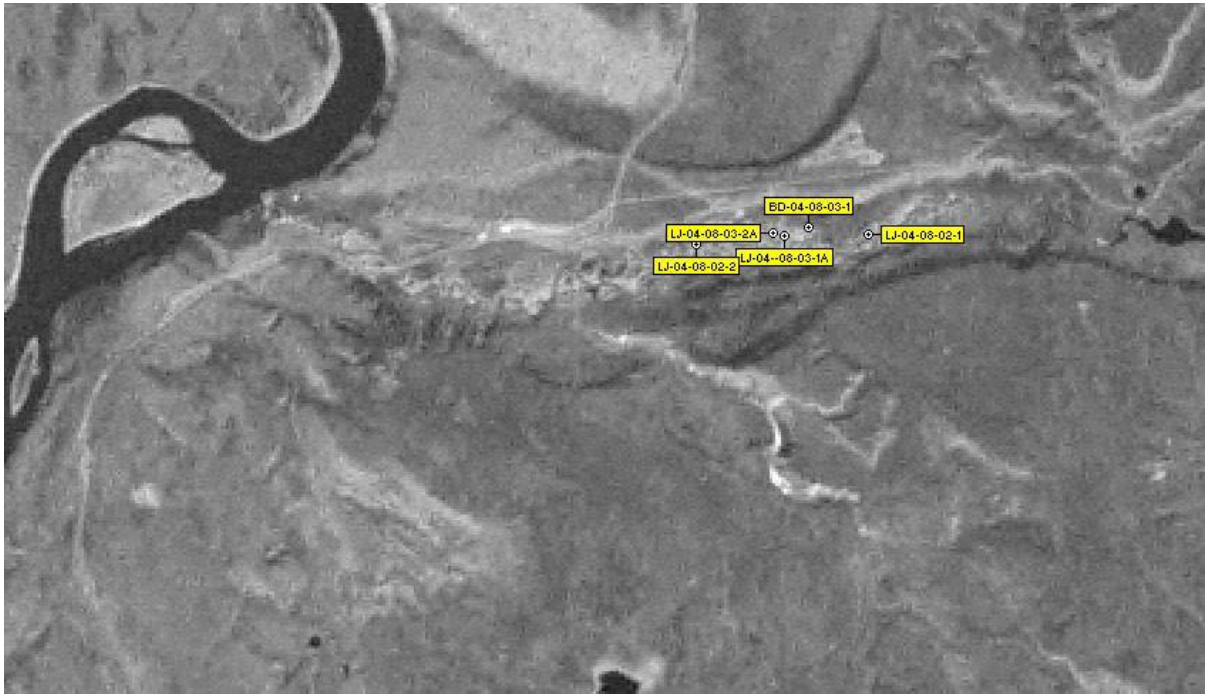
Figure 6: Logjams and Beaver Dams located on Tatchun Creek surrounding Beaver Dam Pond downstream of Tatchun Lake on August 2 and 3, 2004.

Logjams and Beaver Dams were flagged and mapped; they were all located upstream and downstream of Beaver Dam Pond. Logjam 1A, 2, and 2A were removed with a small chainsaw and manual labor with the help of local residents from Little Salmon Carmacks Village residents (Figure 6).

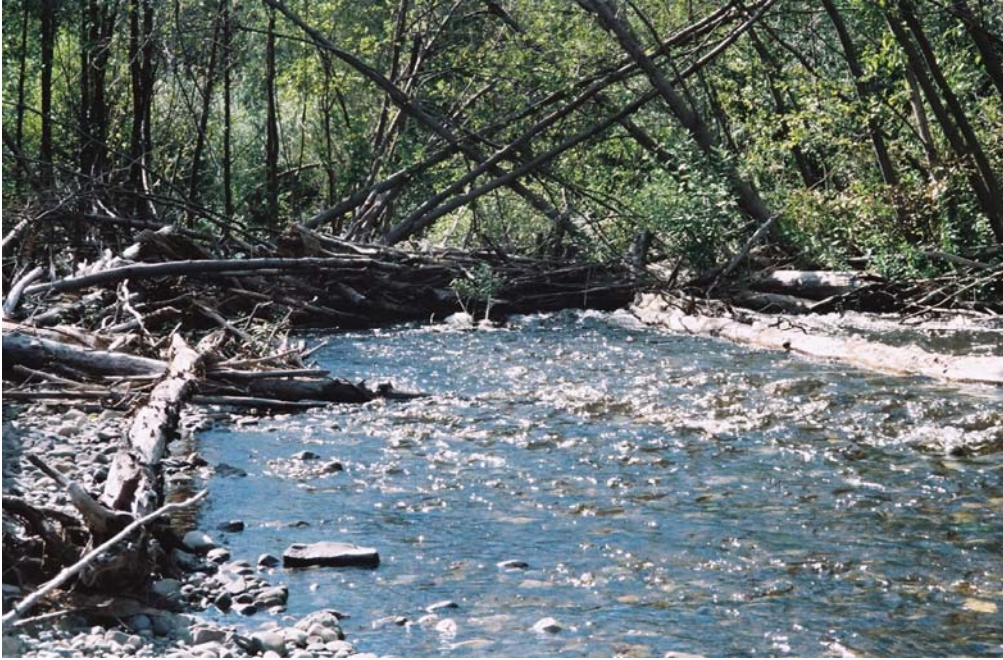
Figure 8: Logjam 2A, upstream view on Tatchun Creek.

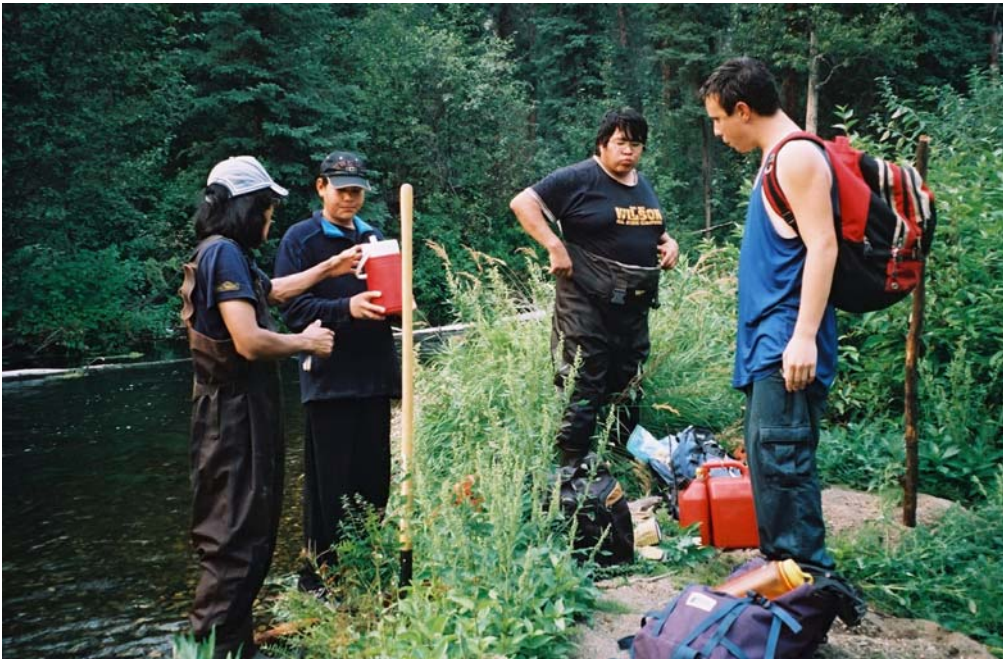
Figure 9: Taking a break from removing a logjam (2A) on Tatchun Creek.

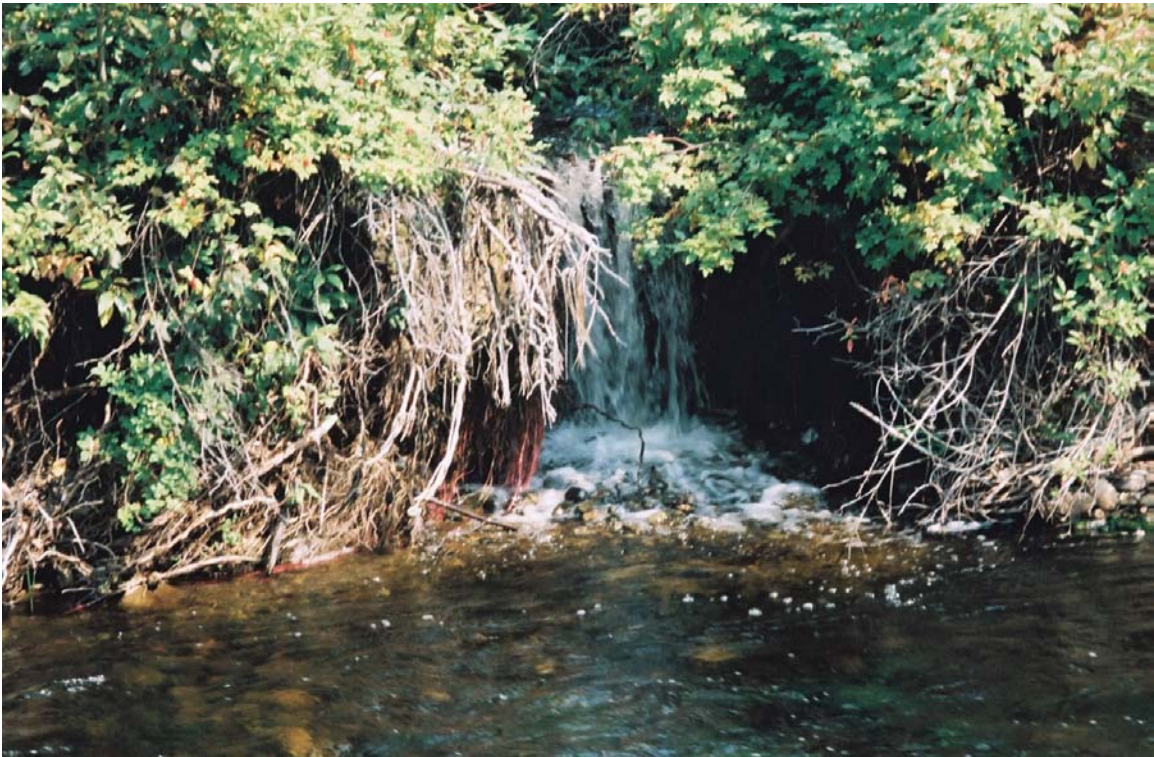
Figure 11: Headcut from Beaver Dam Pond onto Tatchun Creek.
