BLIND CREEK CHINOOK SALMON ENUMERATION WEIR, 2006

CRE-37-06

Prepared for: The Yukon River Panel
Restoration and Enhancement Fund

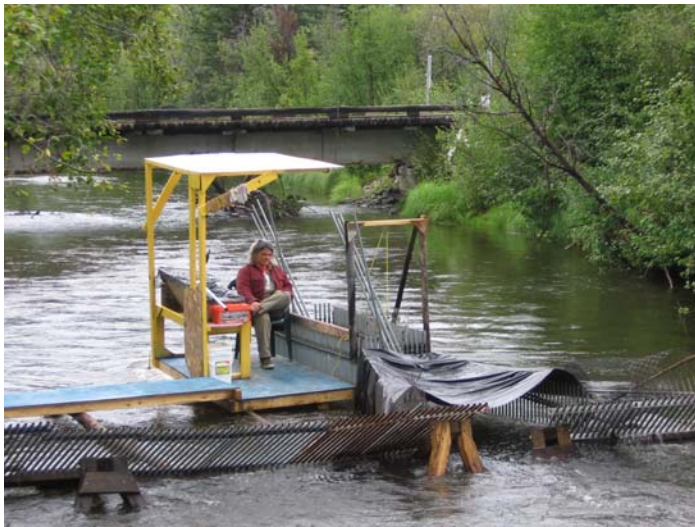
Figure 2. View of counting chamber and sampling station looking upstream.

Construction of the weir was initiated on July 14 using weir materials stored on site from previous operations. As in 2005, the counting chamber was placed mid-stream and at the upstream apex of the fence (Fig. 2). This chamber consisted of conduit panels connected together to form an enclosure measuring 2m (L) X 0.7 m (W) X 1.0 m (H). Two conduit panels, each 2 meters long, were used to connect the chamber to the fence and create a staging area for fish moving into the chamber. The fence was constructed of conduit panels and tripods placed downstream of the counting chamber in a 'V' configuration to direct fish moving close to the bank towards the staging area (Fig.3).

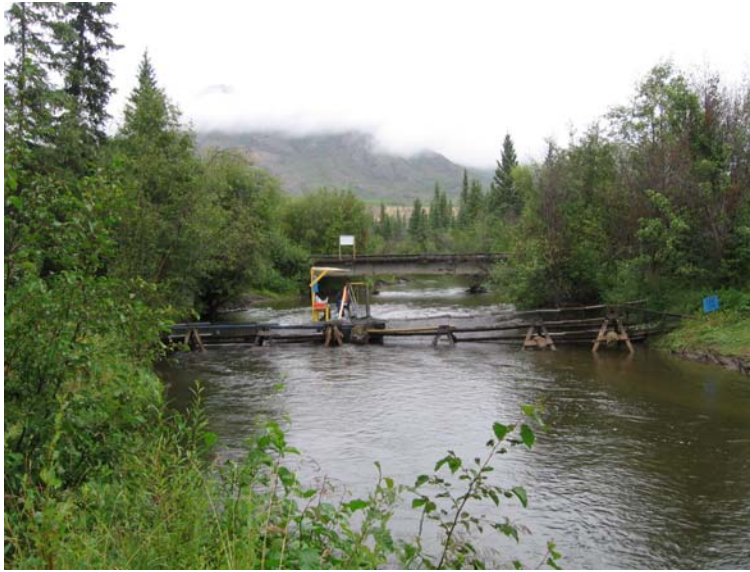
Figure 3. View of weir looking upstream.

After the panels were in place, sand bags were placed along the bottom upstream side of the weir to prevent scouring of the creek substrate and undermining of the structure. A white ‘flashboard’ was secured to the bottom of the counting chamber to improve visibility of salmon passing through. A platform was placed alongside the counting chamber for enumerating and sampling fish and accessed from the bank via a wooden walkway. Similar to last year, black poly was draped over the staging area to prevent fish moving in from seeing weir attendants and activity on the platform.

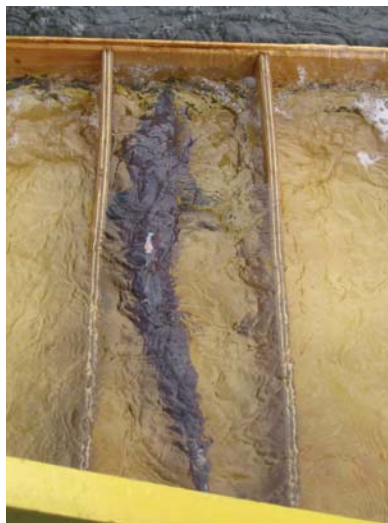
Figure 4. Chinook salmon resting in recovery chamber after sampling.

As in 2005, a recovery container was placed immediately upstream of the sampling platform to hold fish after sampling (Fig. 4). This was constructed of plywood and consisted of four shallow chambers to support individual fish. The container was submerged just beneath the surface level to allow some water to flow over the chambers. Chinook held in the chamber after sampling could regain their strength and swim over the top to continue upstream.

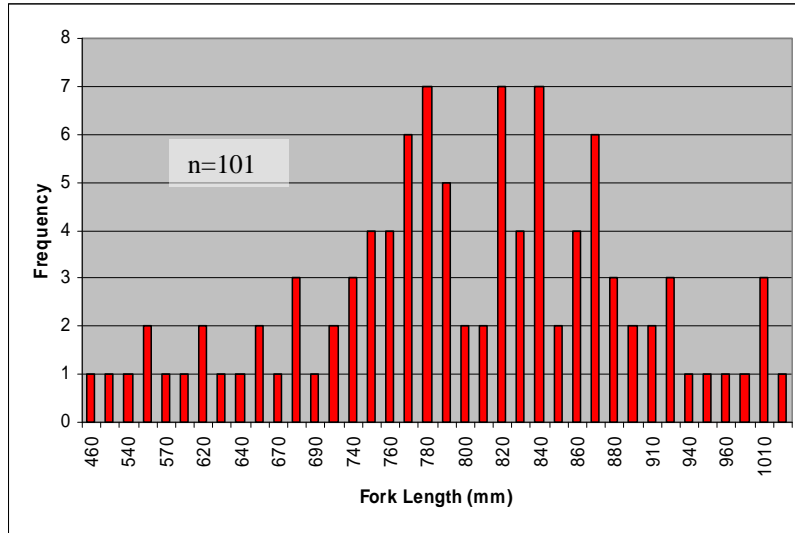
Figure 5. Length frequency of Blind Creek chinook sampled in 2006.

A total of 101 chinook was live sampled during the weir operation (see sampling data, Appendix 4). Of the fish sampled, 41 (41%) were females and 60 (59%) were males (including 10 jacks \leq 630 mm (FL)). The median fork length for females was 840 mm and the range 730 – 1020 mm. The median fork length for males was 770 mm and the range 460 - 1010 mm. Fork length frequencies of chinook sampled are shown in Figure 5. Age was determined from
